**THERMAL TESTING OF THE VISIONLINE 200MM SAFETY  
VENT AIR FLUE KIT IN A FLAT CEILING AND ROOF  
PENETRATION ACCORDING TO APPENDIX F OF  
AS/NZS2918:2018**

Report Number: ASFT21074-PRELIMINARY REPORT  
Issue date: 20 September 2021

## THERMAL TESTING OF THE VISIONLINE 200MM SAFETY VENT AIR FLUE KIT TO AS/NZS2918:2018 APPENDIX F

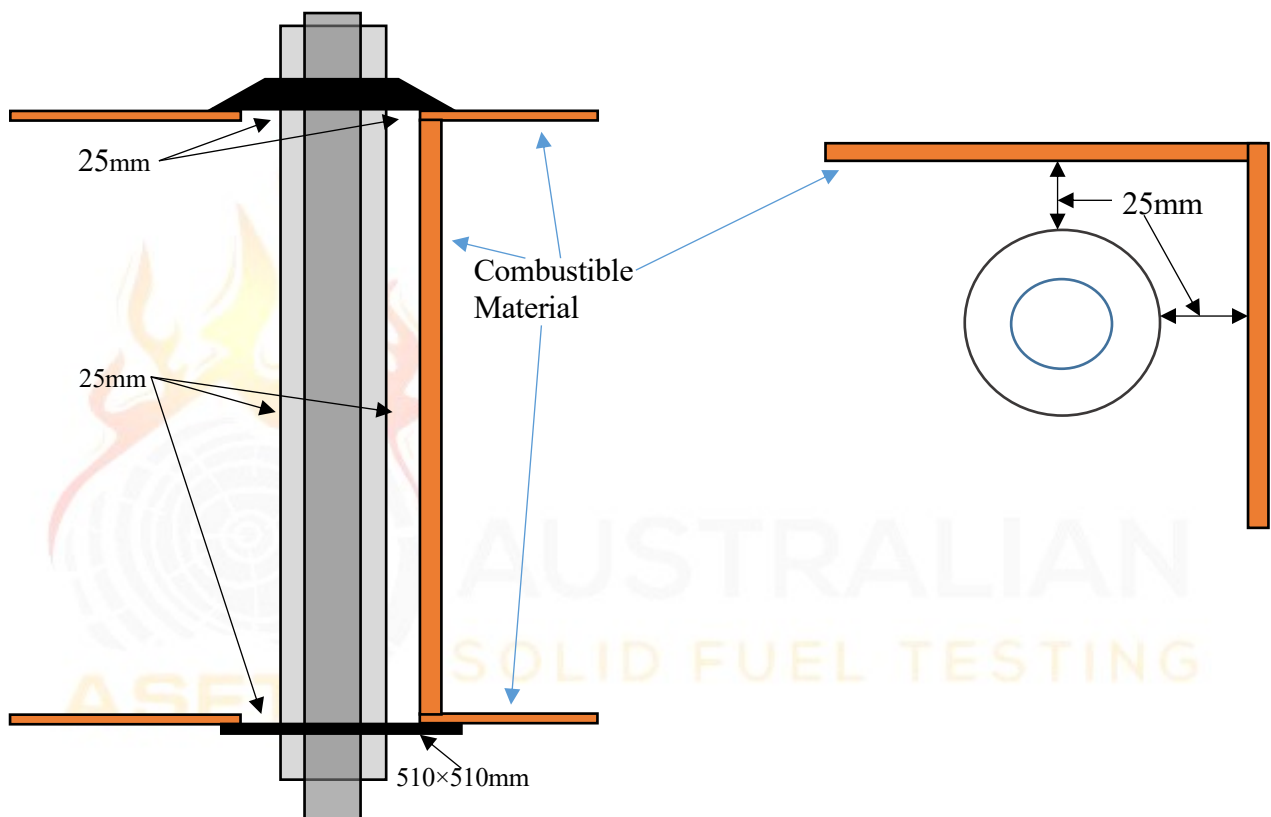
Figure 1 – Clearance Diagram

The Flue system was tested at the following clearances:

Position A – Parallel position

Position B – Corner position

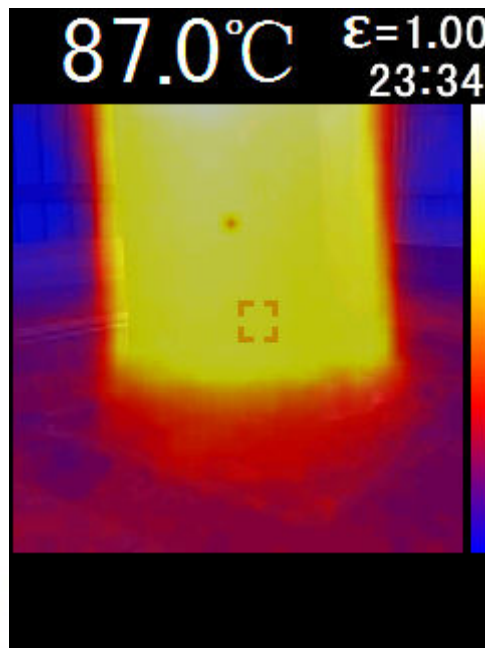
Above Ceiling

### APPENDIX 1: Thermal images of flue during testing

Appendix 1 is thermal images of the flue kit during testing  
Appendix 2 is the installation manual/Instructions for the flue kit
