PREPARED FOR
JETMASTER (VIC) PTY LTD

**THERMAL CLEARANCE TESTING OF THE VISIONLINE
TAURUS INBUILT AND ZERO CLEARANCE BOX**

Report Number: ASFT20016-1
Issue date: 28 May 2020

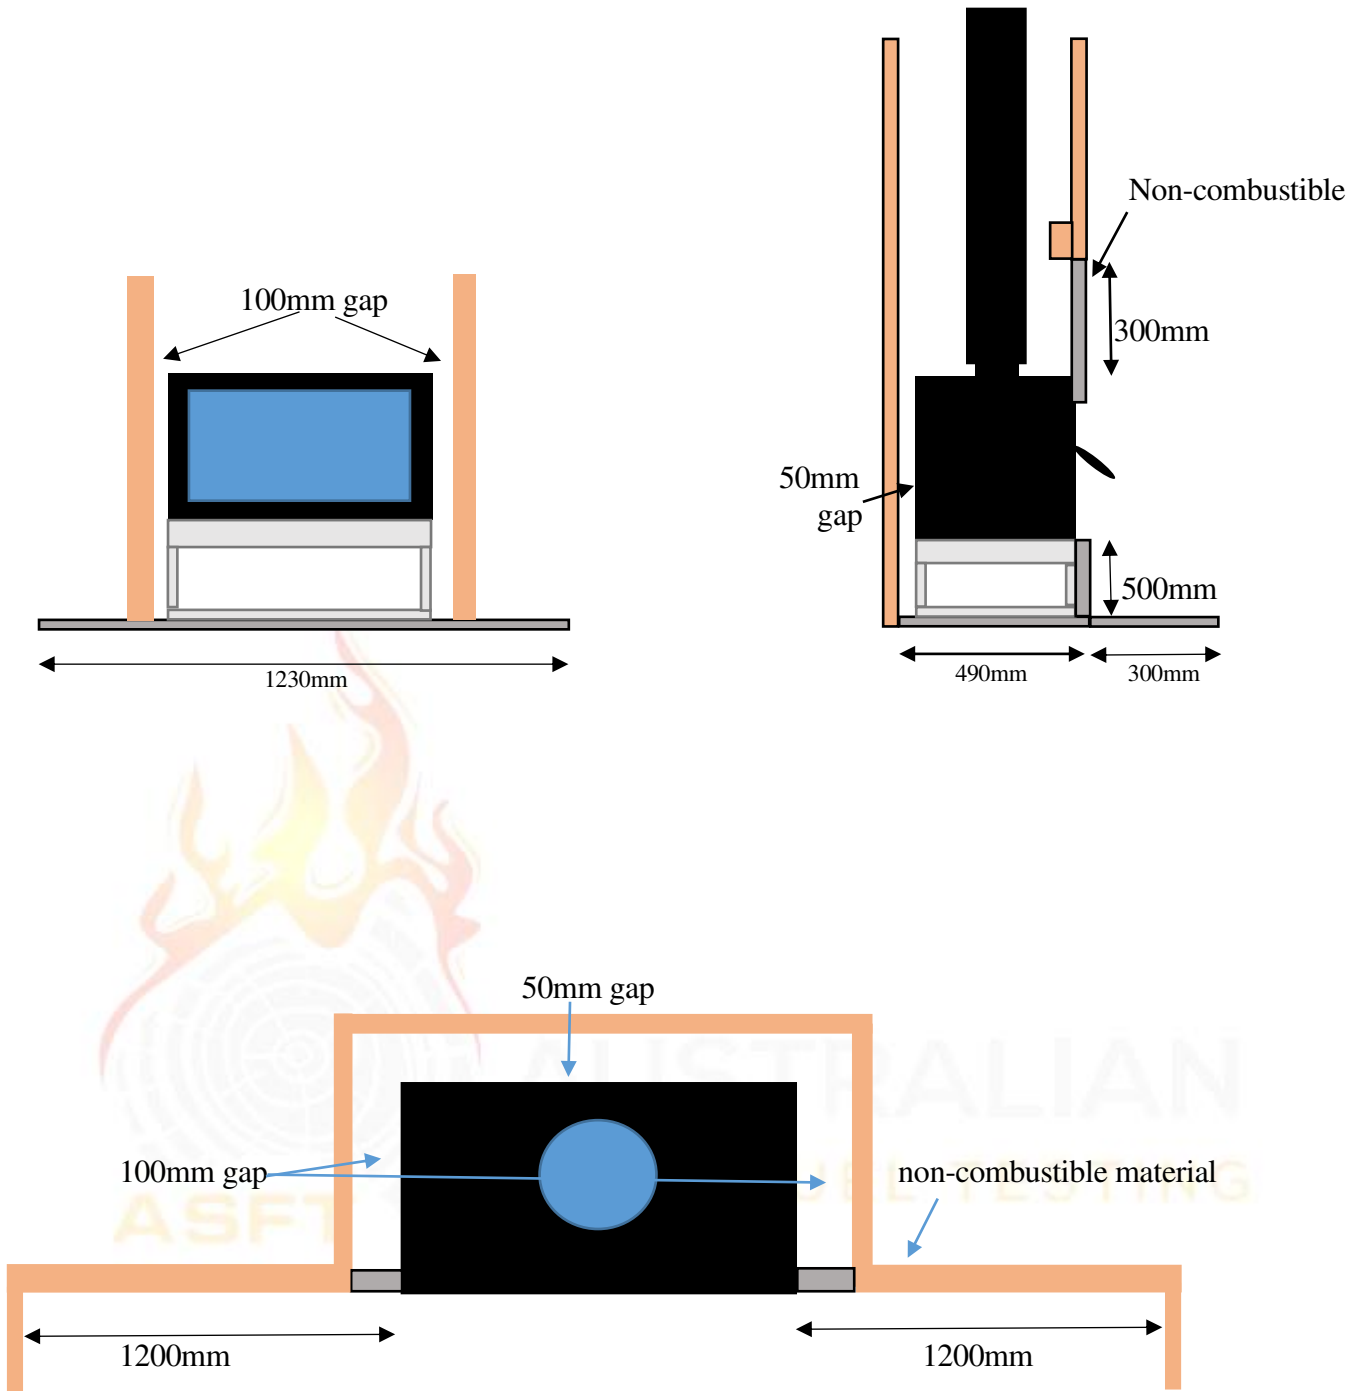
Figure 1 – Clearance Diagram

The appliance and Flue Combination should be installed at the following clearances:

- The mantle shelf and mantle upright clearances was not tested and should be installed as per clause 3.4.1.3(b) of AS/NZS 2918:2018
- Flue ceiling penetration must have a 50mm air gap in all directions around the outer casing of the from combustibles.

- The outer casing of the flue (12") must be raised 65mm above the zero clearance box
- The inner galvanised casing of the flue (10") must be vented into the zero clearance box outer skin and be sealed to prevent venting into the enclosure

- The front wall of the enclosure must be made of non-combustible material to a height of 300mm above the zero box from the hearth and must extend to 100mm either side of the zero box.

- 300mm from the top of the Zero Clearance box to the first internal wall noggin above the front of the appliance.
- The Zero clearance box as tested must have air gaps of 8mm above the appliance and 3mm on both the sides of the appliance.

- Combustible material/rear wall of the enclosure must be a minimum of 50mm from the rear of the appliance zero clearance box
- Combustible material/side wall of the enclosure must be a minimum of 100mm from the side of the appliance zero clearance box

The VisionLINE Taurus Inbuilt and Zero Clearance box with a Wildcat 6” triple skin flue kit, conforms to the requirements of Australian/New Zealand Standard 2918:2018, with respect to floor and Zero enclosure internal surface temperatures, when tested in the test position shown in Figure 1 of this report in accordance with Appendix B of AS/NZS2918;2018.
